**SHEAR REPAIR OF P/C BOX BEAMS USING  
CARBON FIBER REINFORCED POLYMER (CFRP) FABRIC**

Research Report  
KTC-06-01/FRT114-01-1F

January 2006

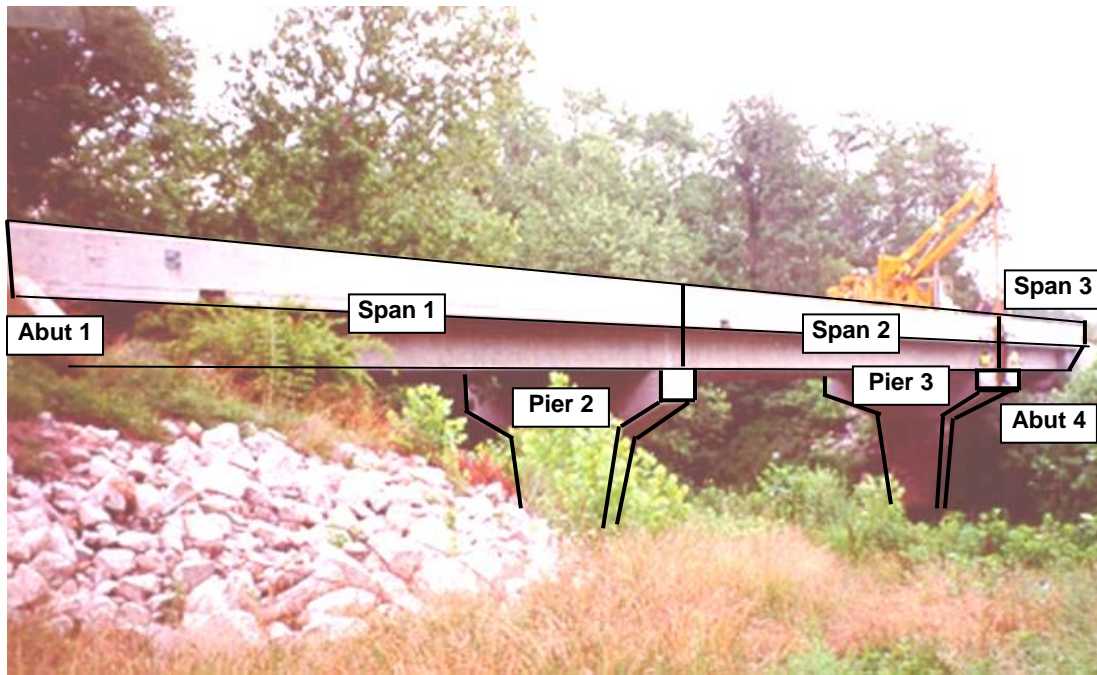
The KY3297 Bridge over Little Sandy River is located in Carter County, KY. It is a three-span [68-98-42 ft (21-30-13 m)] composite, precast prestressed spread box-beam bridge (Fig. 3.1).

**Fig. 1.1. The KY3297 Bridge over Little Sandy River, Carter County, KY.**

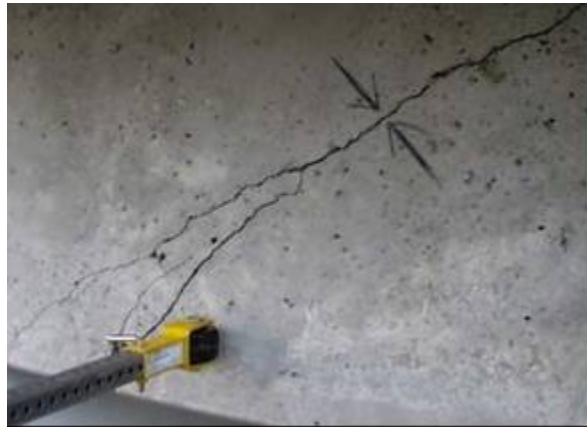
- April 1996. Shear cracks in all four box-girders of the bridge center span. Cracks were estimated to be 1/8" wide and 6 to 8 feet long.
- June 1996. A special in-depth snooper inspection was performed. All cracks in the center span were measured and documented.
- June 1997. Annual inspection scheduled and performed.
- June 1998. Annual inspection scheduled and performed. Following this inspection, it was determined that the shear cracks in the center span (Span 2) had continued to grow in magnitude and number. New shear cracks were also discovered in Spans 1 and 3. Typical shear cracks are shown in Figs 1.2 and 1.3.

**Fig. 1.2. Typical shear cracks in bridge girder.**

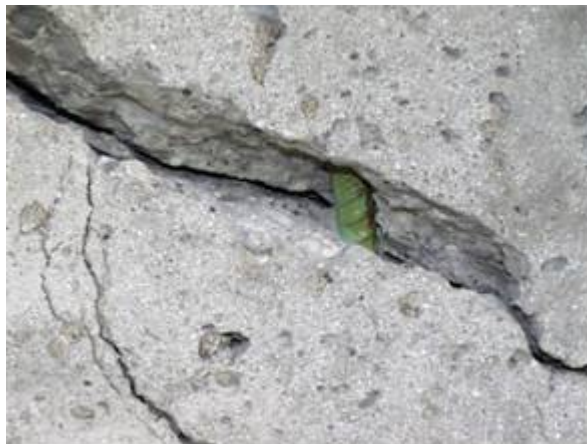
**Fig. 1.3. Shear crack with exposed shear reinforcement.**

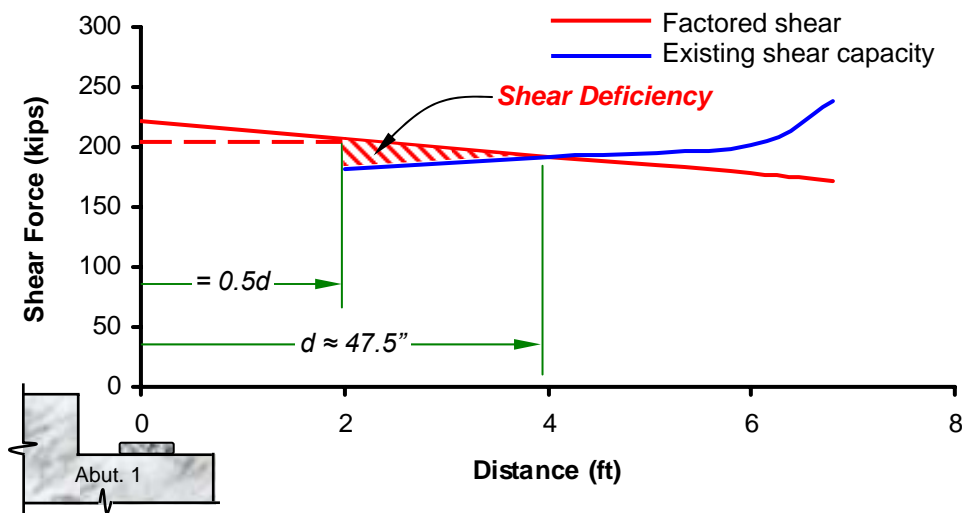
Following the in-depth snooper inspection in 1996, a detailed evaluation of the bridge was carried out by the Division of Bridge Design, Kentucky Transportation Cabinet. The evaluation confirmed that the bridge was indeed deficient in shear reinforcement as depicted in Figs. 3.1 – 3.6. It is apparent, as demonstrated in Figs. 3.2 and 3.3, that the major deficiencies in shear are indeed in the center span (Span 2) while Span 3 shows little of such problem (Figs. 3.5 and 3.6). Detailed computations are tabulated in Appendix I.

**Fig. 3.1. Shear strength evaluation near Abutment 1 of Span 1.**

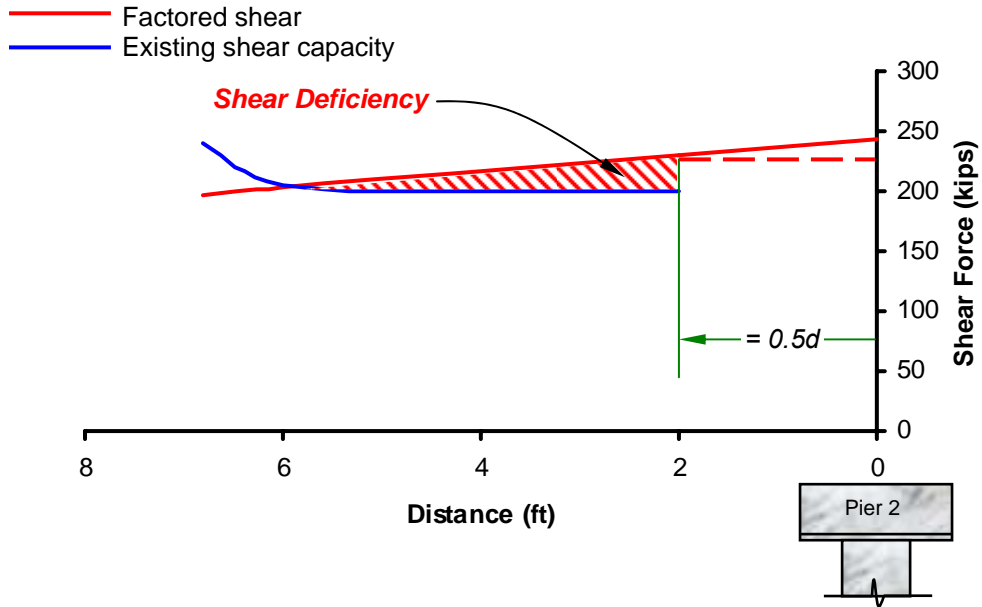
Fig. 3.2. Shear strength evaluation near Pier 2 of Span 1.

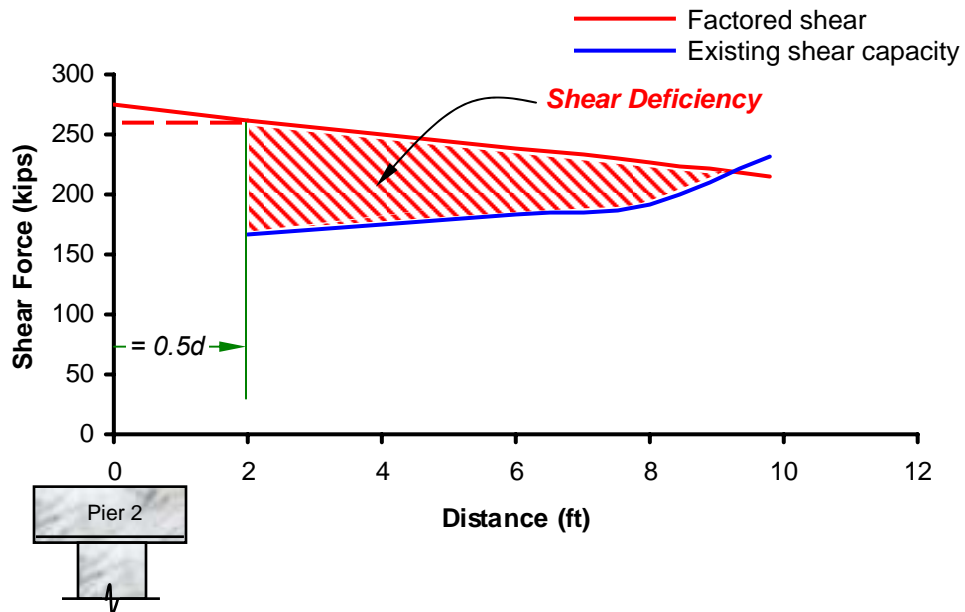
Fig. 3.3. Shear strength evaluation near Pier 2 of Span 2 (Center span).

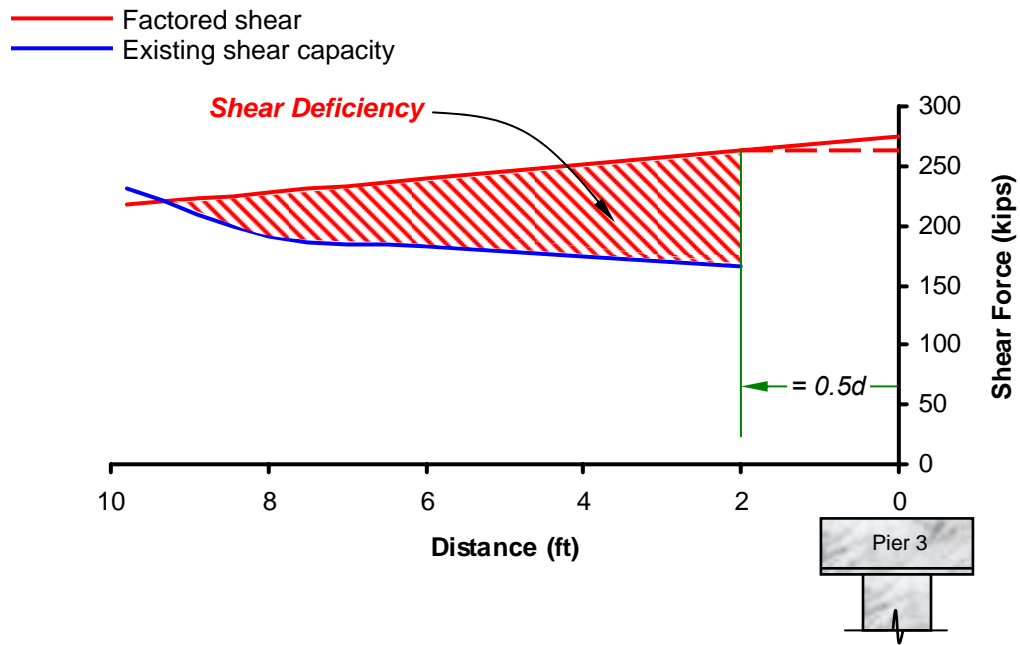
Fig. 3.4. Shear strength evaluation near Pier 3 of Span 2 (Center span).

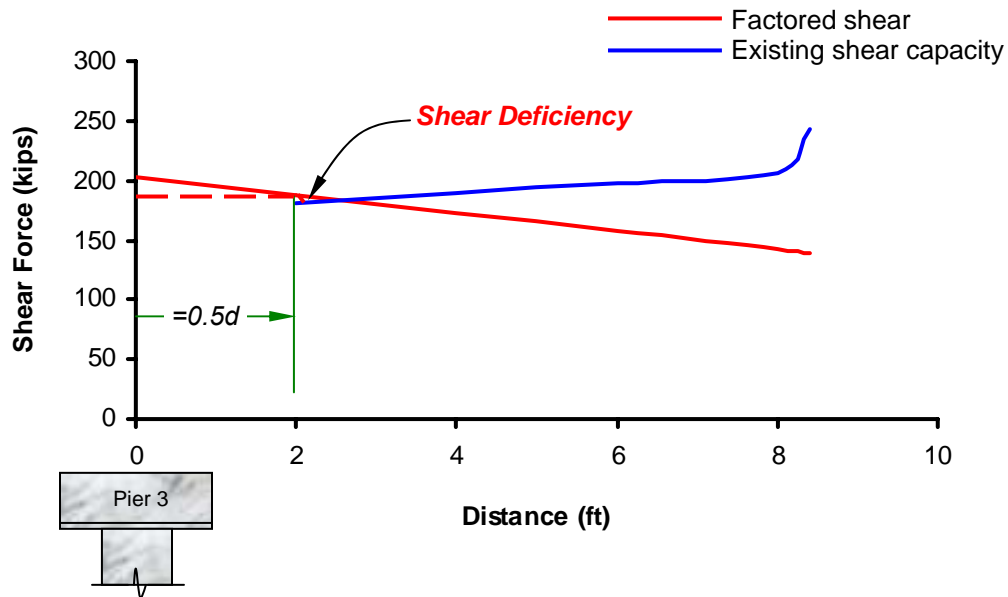
Fig. 3.5. Shear strength evaluation near Pier 3 of Span 3.

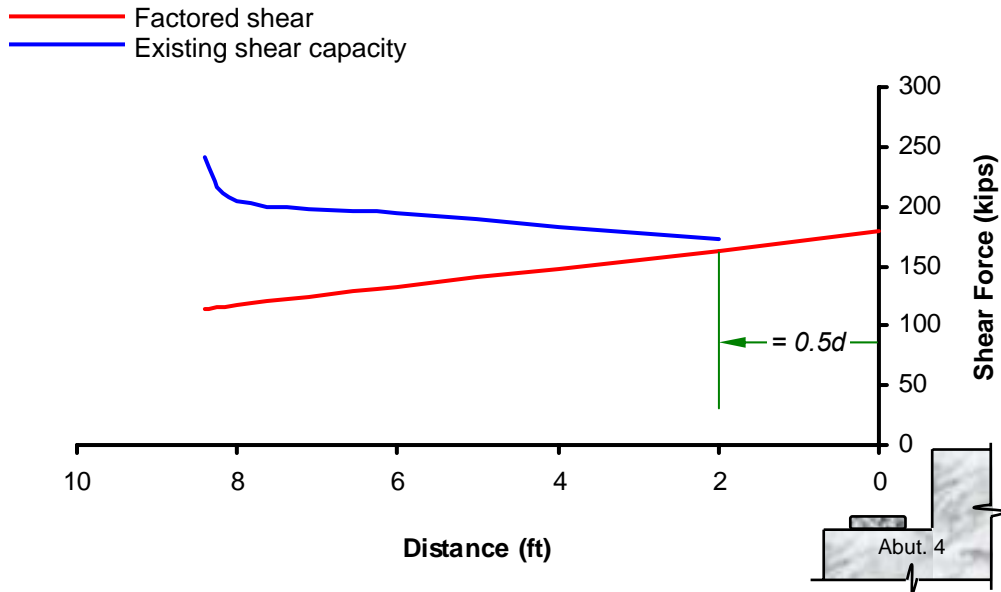
**Fig. 3.6. Shear strength evaluation near Abutment 4 of Span 3.**

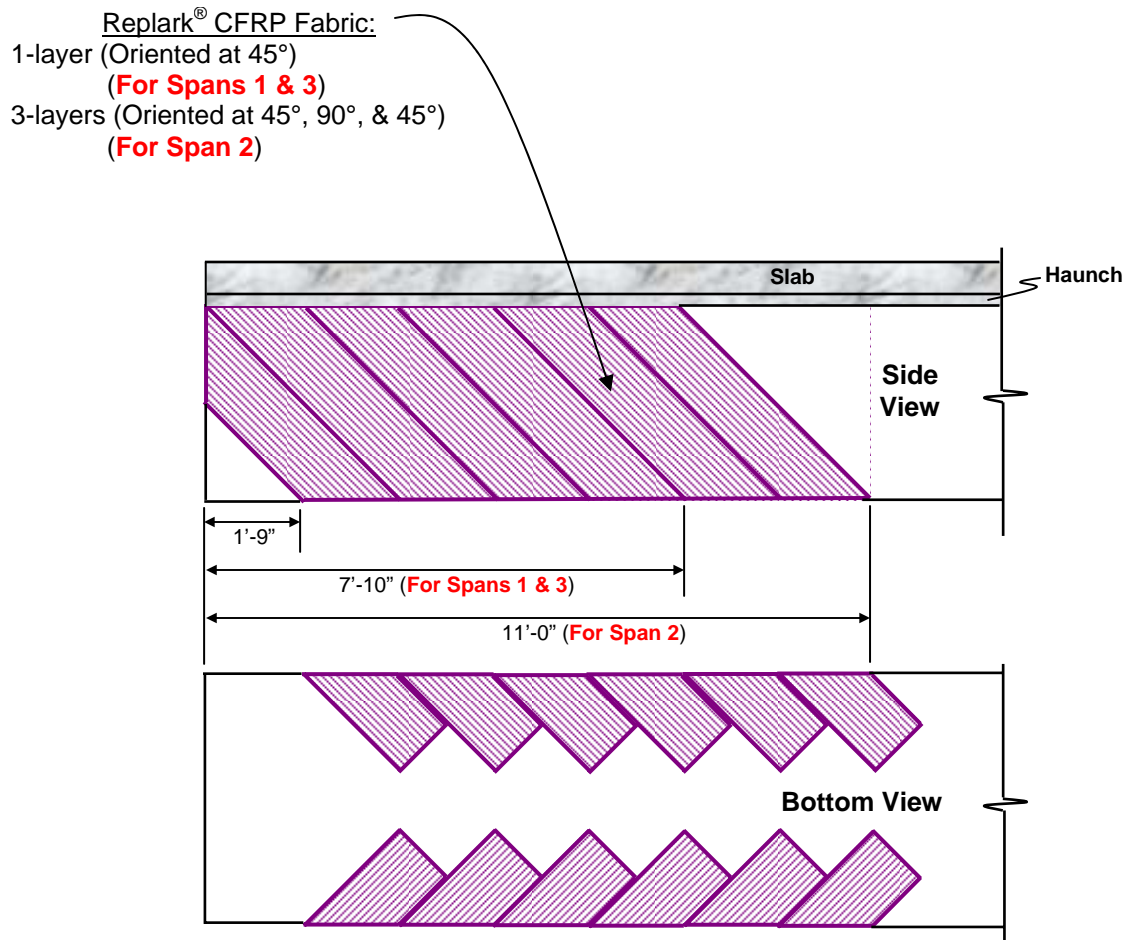
**Fig. 3.7. Typical shear strengthening layout with a single layer of CFRP fabric placed at 45° with respect to the beam axis.**

As described in previous sections, the shear strength of the existing box-girders was increased with the use of CFRP composites. It has been determined from the analytical results that Spans 1 and 3 needed to be strengthened with one-sheet/layer of Replark® 30 CFRP fabric while Span 2 with three-sheets/layers of the same material. Fig. 3.7 shows a schematic of the design layout for a single layer of CFRP fabric. Detailed calculations of the design are presented in Appendix I.

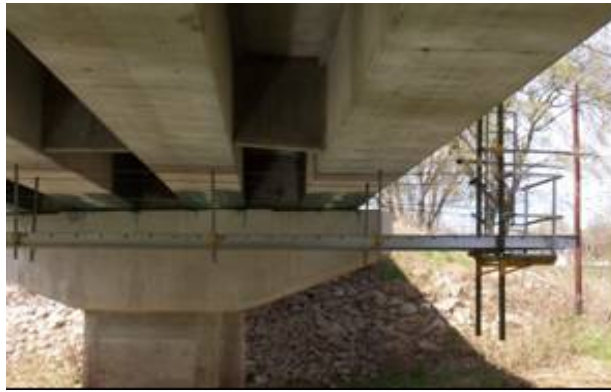
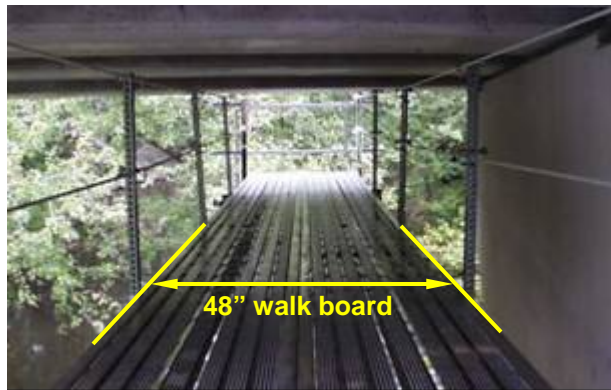
Since the bridge was built over a waterway, typical scaffolding and/or lifts from the ground were not feasible. As a result, access to the bridge beams was made possible by the use of the Swing-Lo<sup>®</sup> 48" Wrap-A-Round Parapet Scaffolding System (see Figs. 4.1.a and b). The system was mounted on the New Jersey Barriers, and was completely adjustable and moveable along the bridge with a 48" walk board as shown in Fig. 4.1.b.

**Fig. 4.1. Swing-Lo<sup>®</sup> Scaffolding System.**

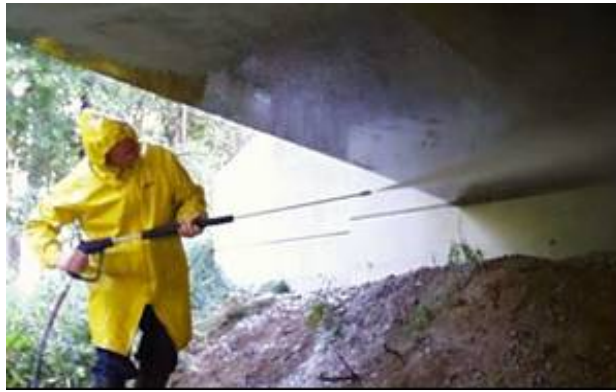
**Fig. 4.2. Power washing of concrete surface.**

The surface of the box beams was properly cleaned and grinded (Figs. 4.2 and 4.3) before starting the crack repair process. This particular step was to ensure the removal of contaminants and all loose concrete particles and debris. This enabled a solid bond between the beams and the CFRP fabric.

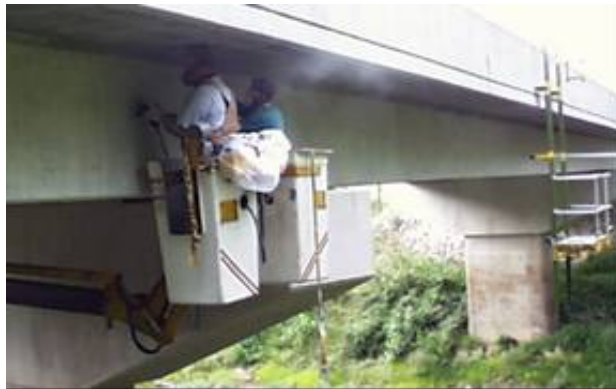
**Fig. 4.3. Surface grinding.**

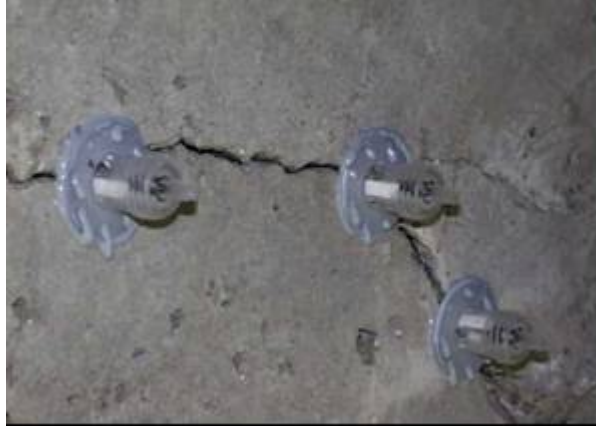
**Fig. 4.4. Mounting of injection ports.**

The cracks were subsequently repaired by using the HILTI® CI 060 Epoxy Injection System. The goal of this process was to partially restore the beam's capacity. The application followed these steps: (1) mounting of injection ports. Injection ports were spaced approximately 6-inch (150 mm) apart from one another (Fig. 4.4); (2) seal

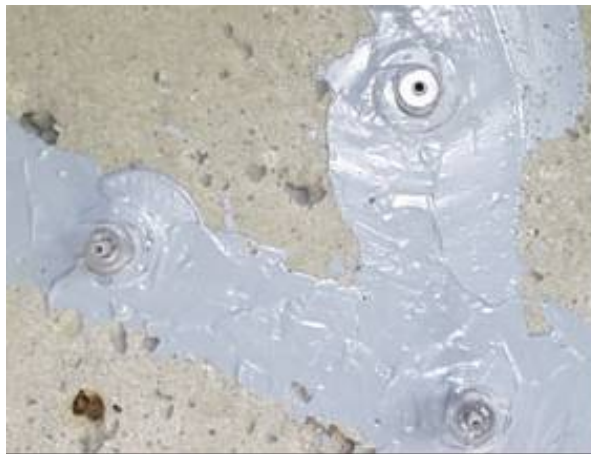
**Fig. 4.5. Sealed cracks.**

cracks (Fig. 4.5), which requires 24 hour curing time; (3) injection of CI 060 epoxy resin (Fig. 4.6); and (4) grinding off the injection ports and excess crack sealant to achieve a smooth finish (Fig. 4.7). Detailed information about the HILTI® CI 060 EP Injection System can be found in Appendix II.

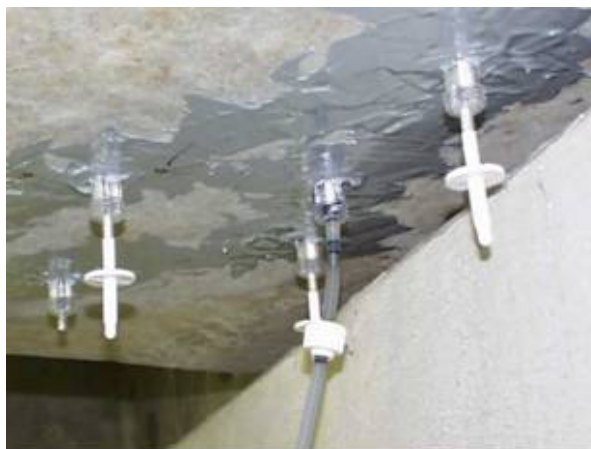
**Fig. 4.6. Epoxy injection process.**

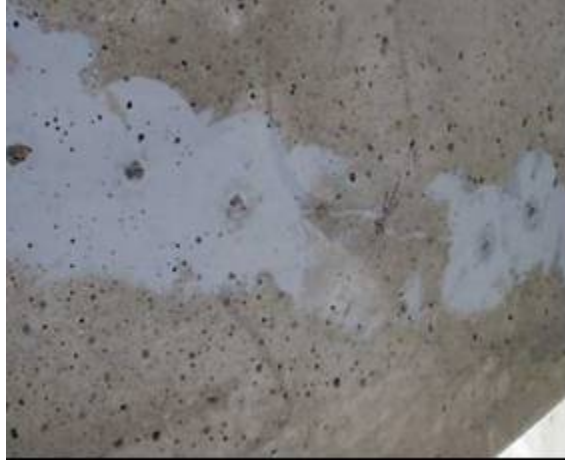
**Fig. 4.7. Repaired surface with grinded off injection ports and excess sealant.**

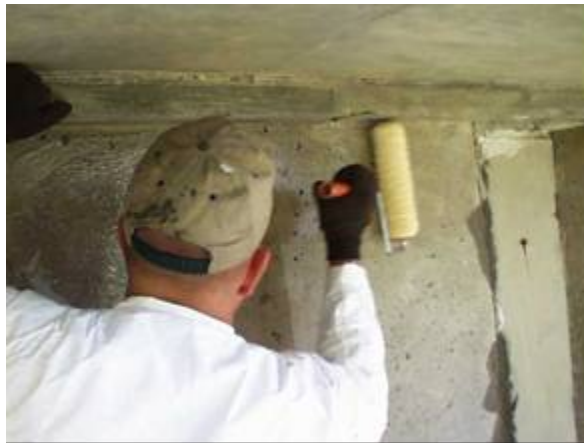
**Fig. 4.8 – Primer application.**

- **Step 1 – Primer application:**  
To improve the strength of the concrete, a coat of primer (PS401) was applied (Fig. 4.8). The primer was also intended to improve the bonding between the concrete and the CFRP fabric.

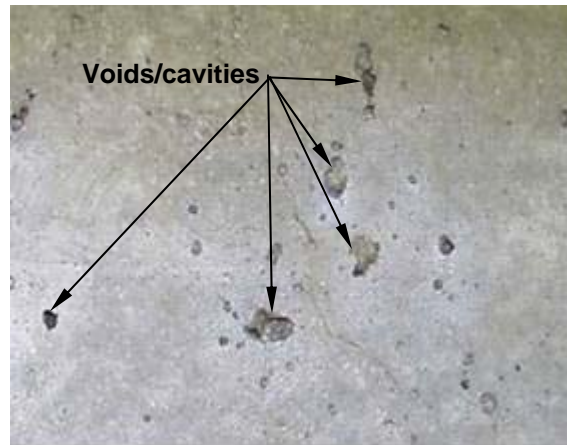
- **Step 2 – Putty application:**  
This step was necessary after the discovery of numerous voids and/or cavities on the surface of the beams (see Fig. 4.9). Voids and/or cavities can cause air

**Fig. 4.9 – Voids and cavities on the beam surface.**

bubbles to form during the CFRP fabric application process which can negatively affect the performance of the CFRP system. The Replark® L525 putty was used to fill these voids and/or cavities as shown in Fig. 4.10.

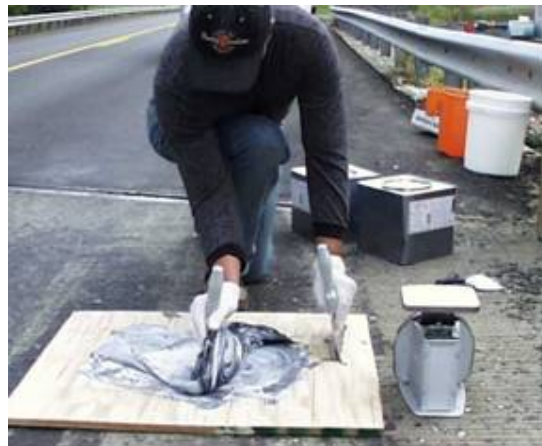
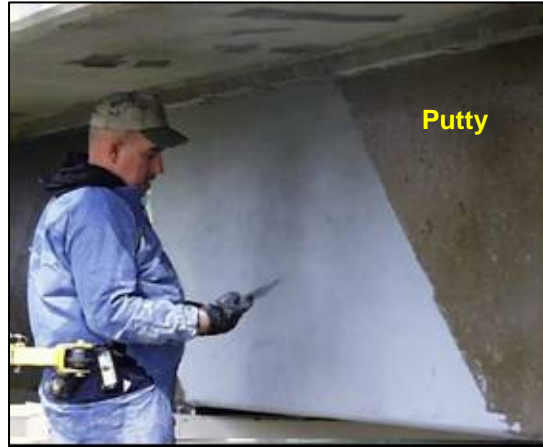
**(a) Mixing putty**

**Fig. 4.10 – Putty application process.**

**(b) Putty application**

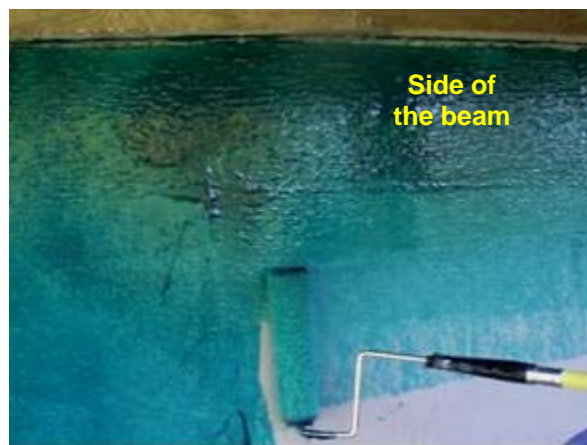
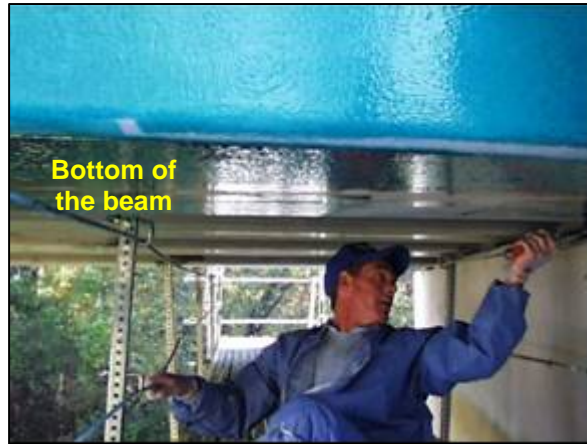
**(a) Resin undercoat to side of the beam.**

**Fig. 4.11 – Resin undercoat application.**

(b) Resin undercoat to bottom of the beam.

- Step 3 – Resin undercoat:  
To bond the CFRP fabric to the concrete, a resin undercoat (L700S-LS) was applied. This resin undercoat was applied to the side and to the bottom of the beam, as shown in Fig. 4.11, where the CFRP fabric would be affixed.

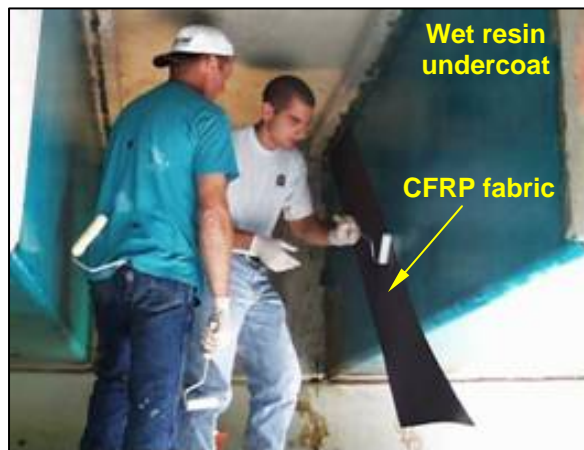
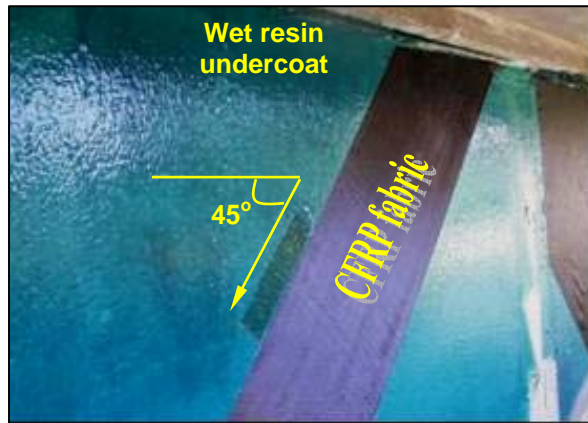
(a) Placement of CFRP fabric onto concrete surface.

**Fig. 4.12 – Placing CFRP fabric onto the concrete surface.**

(b) CFRP fabric place at 45°.

- Step 4 – CFRP fabric application:  
Immediately after the application of resin undercoat, CFRP fabric was placed onto the wet resin with the use of a roller brush as shown in Fig. 4.12.

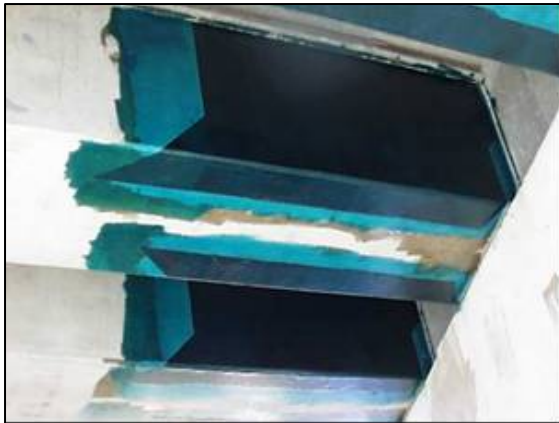
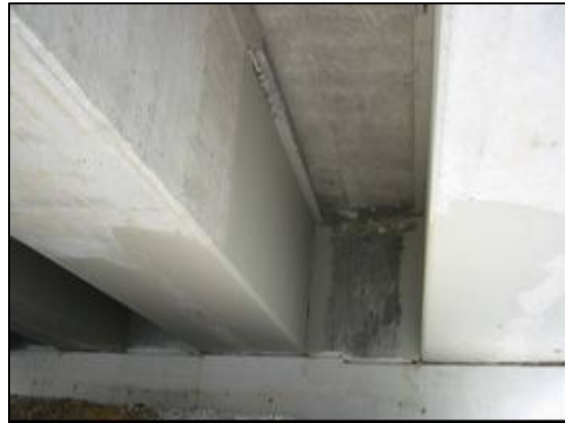
(a) Before painting

(b) After painting

**Fig. 4.13 – Repaired box girders.**

- Step 5 – Resin overcoat and finish coat:  
To offer additional protection to the CFRP fabric, a resin overcoat (L700S-LS) was applied. Note that the resin undercoat – CFRP fabric application – resin overcoat process was completed in the same day. For aesthetic reasons, some of the repaired beams, in particular the exterior ones, were painted with a standard concrete paint. The ‘before’ and ‘after’ pictures are shown in Fig. 4.13.

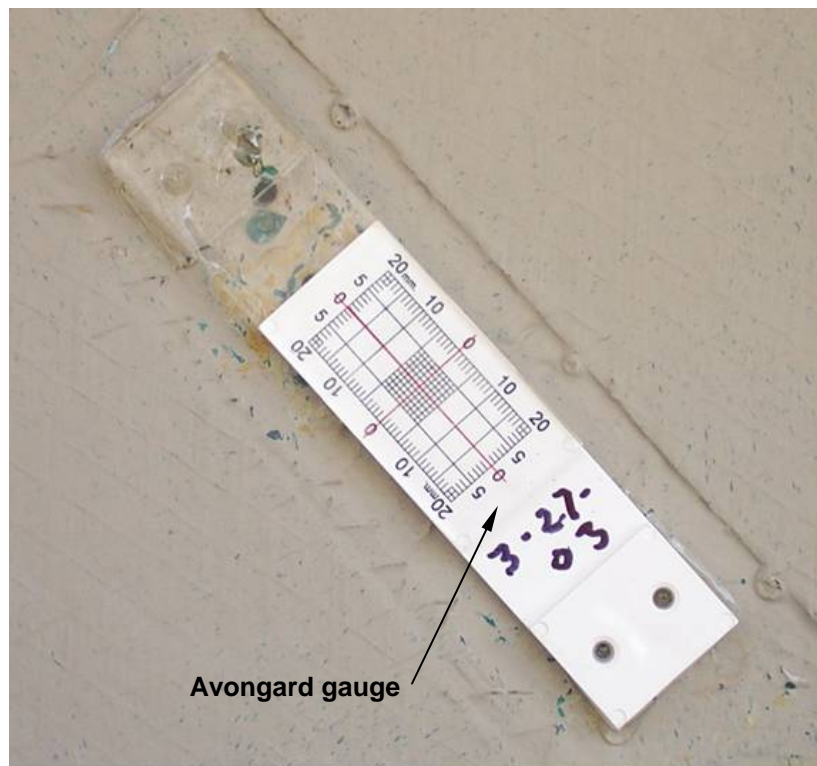
During the application of the Carbon Cloth, approximately thirty 3" X 12" windows were cut to expose critical areas, where cracks had developed on the beams. Avongard crack monitoring gauges (Fig. 5.1) were mounted directly to the beams over the repaired cracks. These gauges can record movement of less than 1mm in any direction. These gauges were read every 30 days for the first three months. The inspection cycle was extended to every 90 days.

**Fig. 5.1 – Crack monitoring gauge affixed to repaired crack location.**

The project was completed in October 2001. As of July 25, 2005, no crack movement has been observed. Also, there is no evidence of new cracks developing. This indicates that the retrofit was a success.

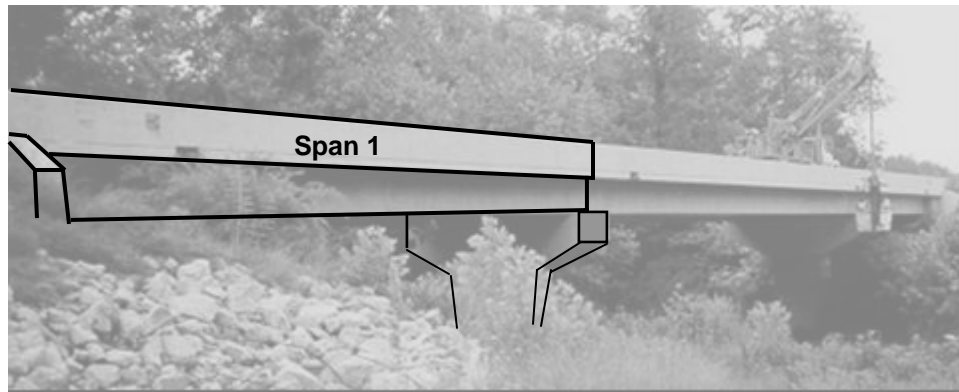
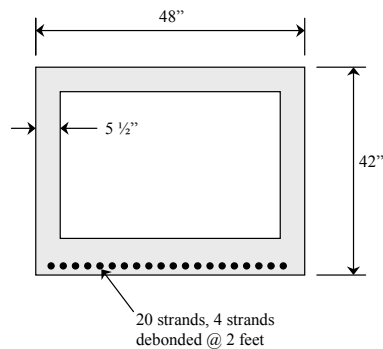
**Fig. I.1 – Schematic of box beam cross section of Span 1.**

Span length, $L_s$	= 68 ft
Beam cross sectional area, $A_b$	= 887 in <sup>2</sup>
Concrete strength, $f'_c$	= 6,000 lb/in <sup>2</sup>
Steel yield strength, $f_y$	= 60 x 10 <sup>6</sup> lb/in <sup>2</sup>
Diam. of shear reinf., $D_v$	= 0.5 in (#4 rebar)
Shear reinf. area/LF, $A_v$	= 0.24 in <sup>2</sup>
Shear reinf. spacing, $s$	= 20 in C.C.
Number of prestressing strands	= 20
Number of draped strands	= 0
Number of debonded strands	= 4
Diam. of strands, $D_{ps}$	= 0.5 in
Area of stands, $A_{ps}$	= 0.153 in <sup>2</sup>
Tensile strength of strands, $f_{ps}$	= 270 x 10 <sup>3</sup> lb/in <sup>2</sup>
Top of slab to strand centroid, $d$	= 47.5 in

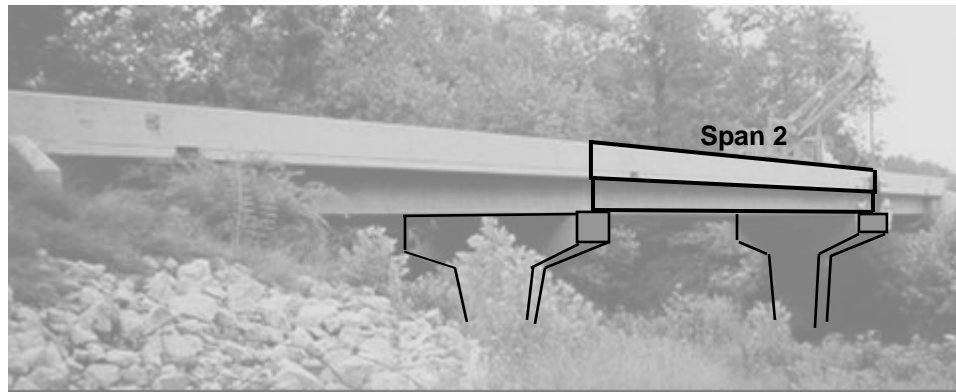
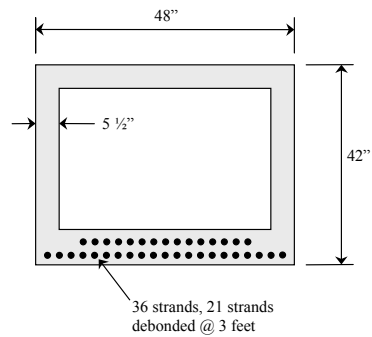
**Fig. I.2 – Schematic of box beam cross section of Span 2.**

Span length, $L_s$	= 98 ft
Beam cross sectional area, $A_b$	= 887 in <sup>2</sup>
Concrete strength, $f'_c$	= 6,000 lb/in <sup>2</sup>
Steel yield strength, $f_y$	= 60 x 10 <sup>6</sup> lb/in <sup>2</sup>
Diam. of shear reinf., $D_v$	= 0.5 in (#4 rebar)
Shear reinf. area/LF, $A_v$	= 0.24 in <sup>2</sup>
Shear reinf. spacing, $s$	= 20 in C.C.
Number of prestressing strands	= 36
Number of draped strands	= 0
Number of debonded strands	= 21
Diam. of strands, $D_{ps}$	= 0.5 in
Area of stands, $A_{ps}$	= 0.153 in <sup>2</sup>
Tensile strength of strands, $f_{ps}$	= 270 x 10 <sup>3</sup> lb/in <sup>2</sup>
Top of slab to strand centroid, $d$	= 46.7 in

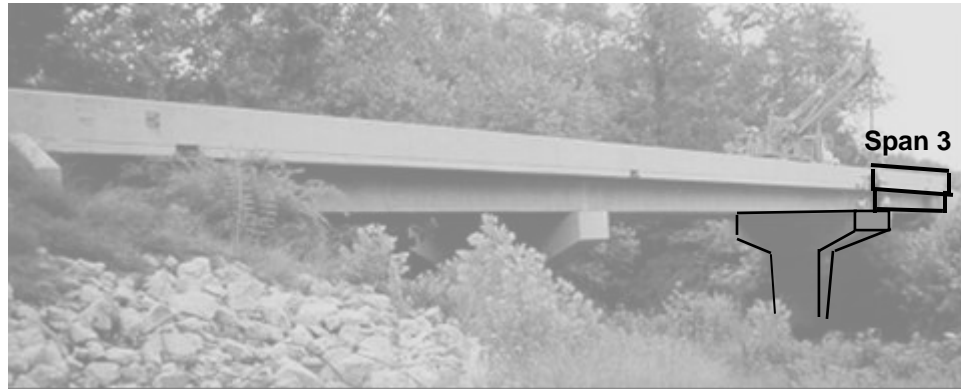
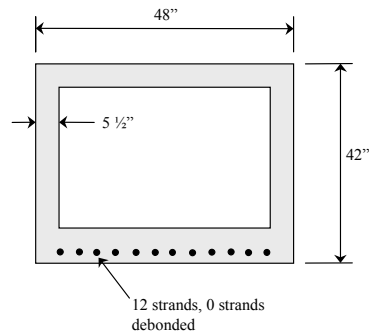
**Fig. I.3 – Schematic of box beam cross section of Span 3.**

Span length, $L_s$	= 42 ft
Beam cross sectional area, $A_b$	= 887 in <sup>2</sup>
Concrete strength, $f'_c$	= 6,000 lb/in <sup>2</sup>
Steel yield strength, $f_y$	= 60 x 10 <sup>6</sup> lb/in <sup>2</sup>
Diam. of shear reinf., $D_v$	= 0.5 in (#4 rebar)
Shear reinf. area/LF, $A_v$	= 0.24 in <sup>2</sup>
Shear reinf. spacing, $s$	= 20 in C.C.
Number of prestressing strands	= 20
Number of draped strands	= 0
Number of debonded strands	= 4
Diam. of strands, $D_{ps}$	= 0.5 in
Area of stands, $A_{ps}$	= 0.153 in <sup>2</sup>
Tensile strength of strands, $f_{ps}$	= 270 x 10 <sup>3</sup> lb/in <sup>2</sup>
Top of slab to strand centroid, $d$	= 47.5 in

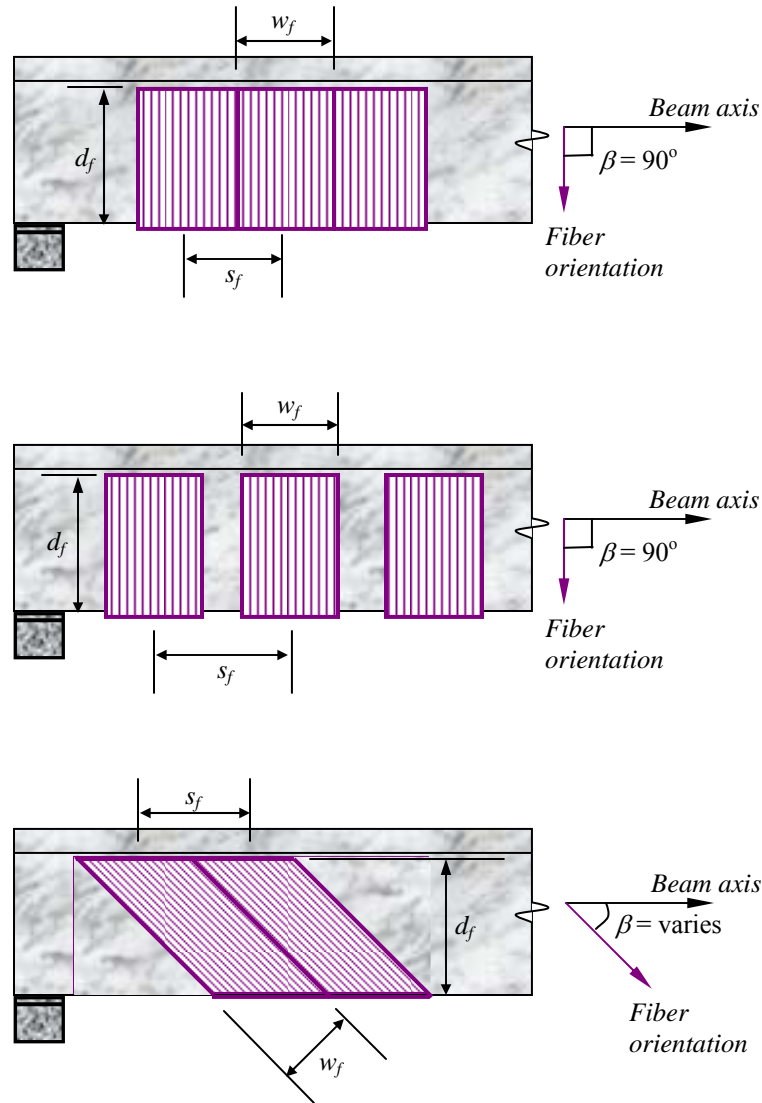
- $n$  = number of FRP plies  
 $t_f$  = thickness of one ply of FRP reinforcement, in  
 $w_f$  = width of the FRP plies, in (Fig. I-4)

**Fig. I-4 – Different wrapping configurations and fiber orientations in shear.**

For U-wraps and 2 sided face wrap (Cases 2 & 3 in Table I-2) without additional anchorage, failure is usually governed by debonding of FRP wrap from the concrete surface. In this case, the effective strain,  $\varepsilon_{fe}$ , shall be determined from the following expression:
